Aquatic Plant Lake Mapping Project

August 23, 2015

The Invasive Species Committee of Ann Lake Property Owners Association (ALPOA) undertook a mapping of the aquatic plants within Ann Lake this on August 11th. This was a follow on to previous mappings of 2012 and 2013. The goal was to determine:

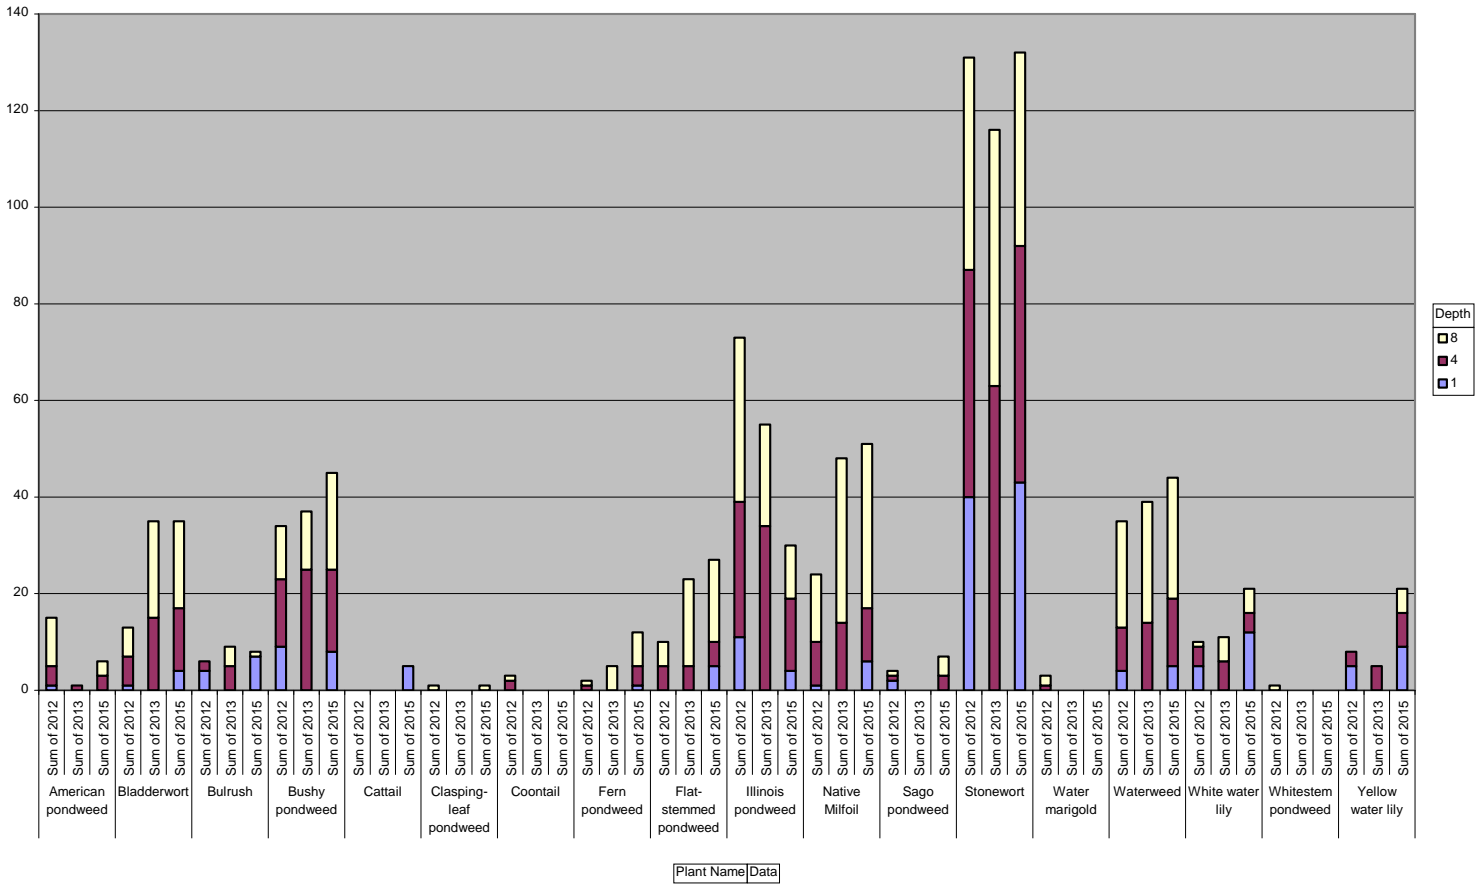
Year to Year Plant Comparison Chart

The above table shows all plants found at all transects for each of the three samplings completed. Since the first sampling, no new plants have been found. One can see that stonewort is the most prominent plant found under 8 feet.

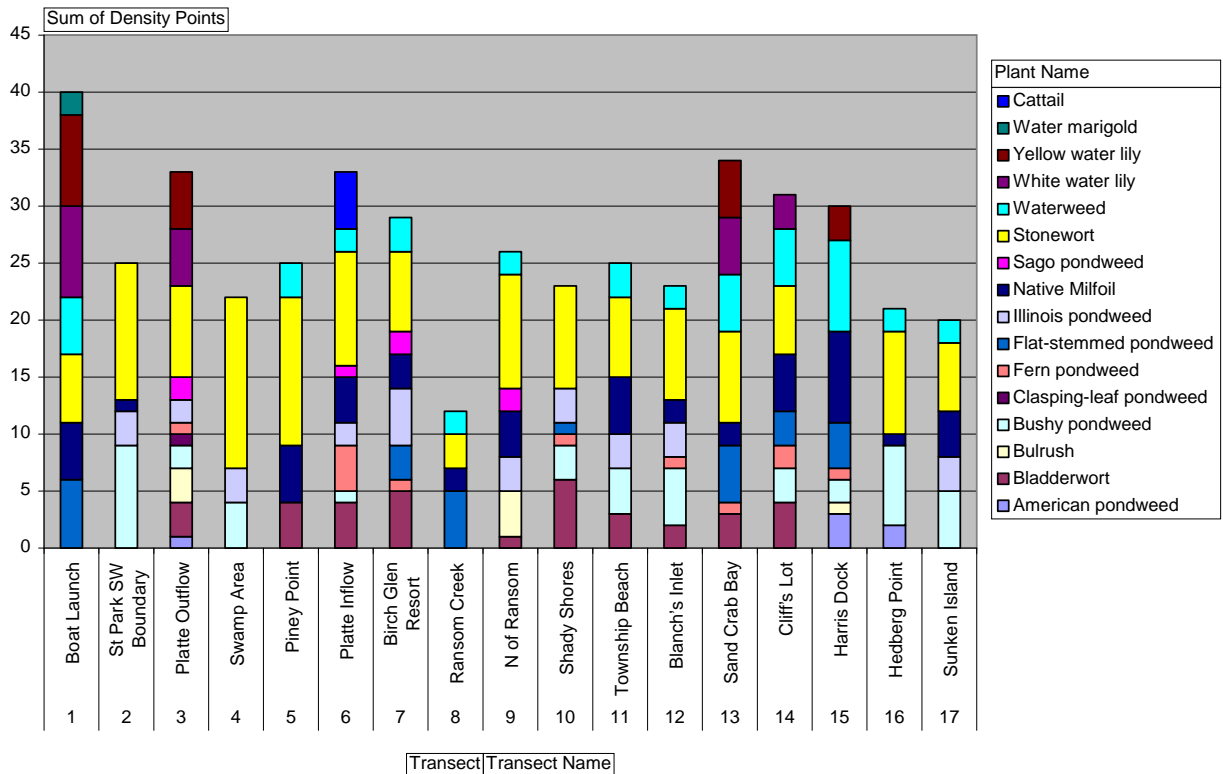
Lake-wide Plant Densities - All Depths

To read the charts, the plants found are shown in the top to bottom order depicted in the key. For example, at the first transect, the Boat Launch, the plants found are: Bushy Pondweed, Flat-stemmed Pondweed, Illinois Pondweed, Native Milfoil, Stonewort, and Waterweed. Using these plants as reference points, it will help you determine the other plants found at each transect.

The most common plants found in the lake were Waterweed, Stonewort, Native Milfoil and Illinois Pondweed, all native.

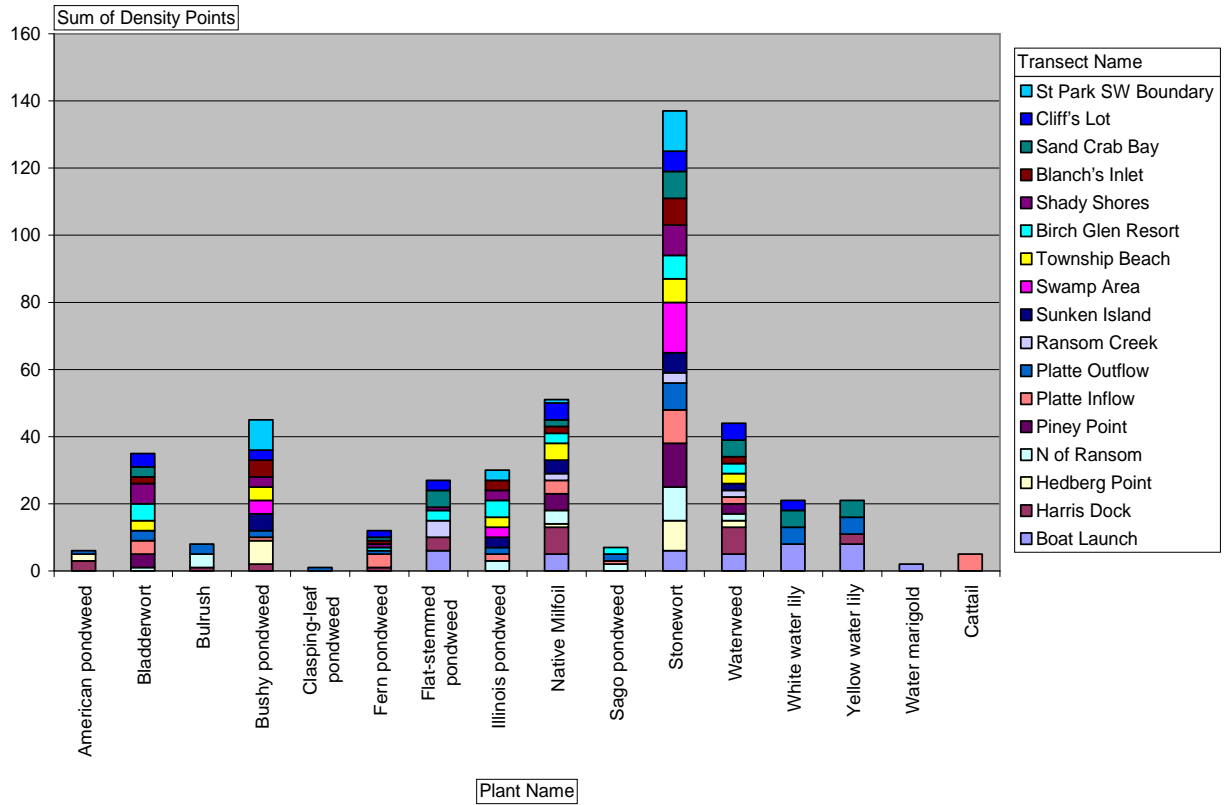
Lake-wide Plant Densities Sorted by Species

Native stonewort was found at almost every transect.

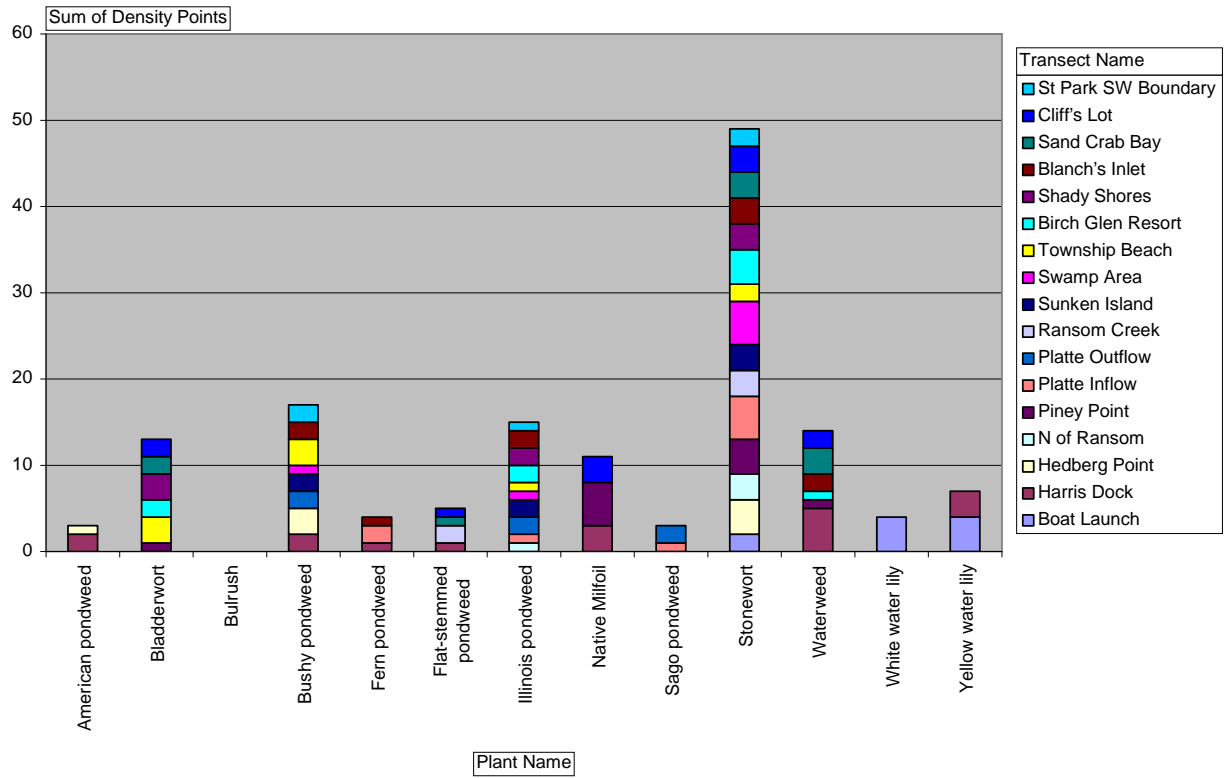
Plant Densities at 4 Feet Sorted by Species

Not all plants are found at each depth. For instance, white and yellow water lilies are only found at 4 foot.

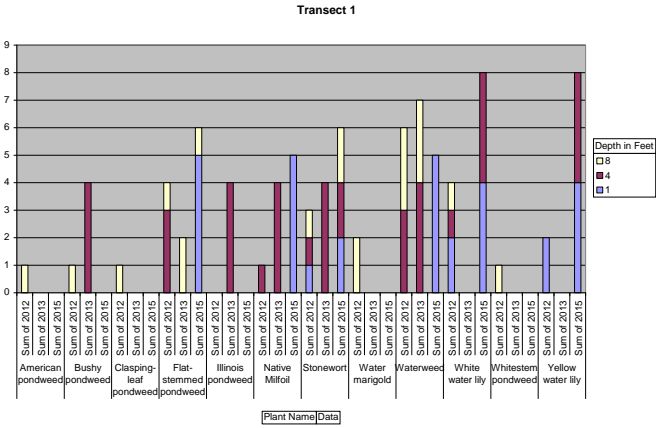
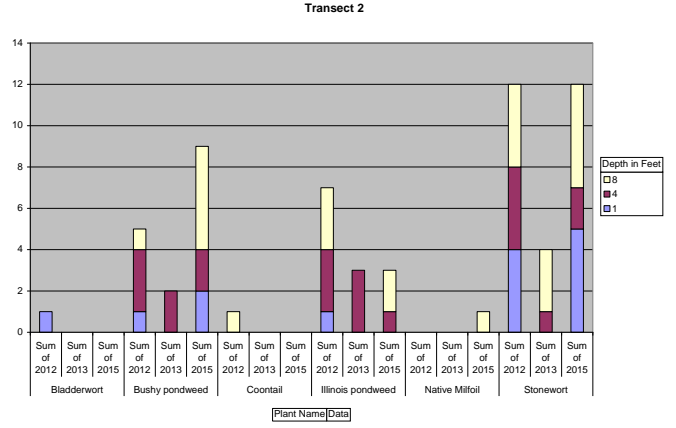
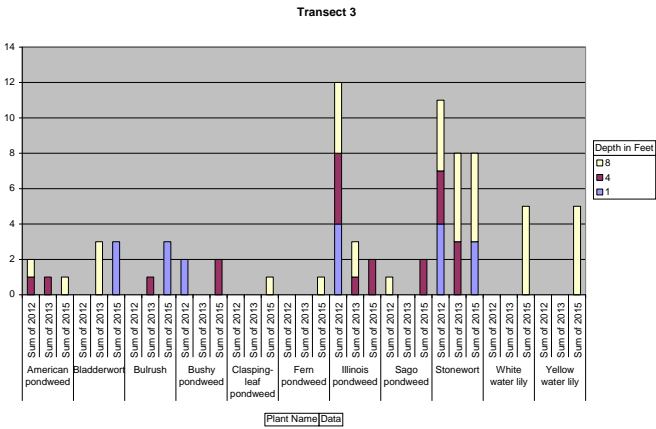
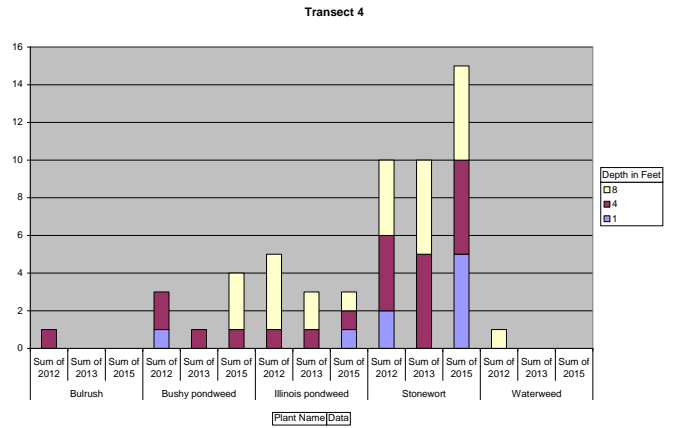
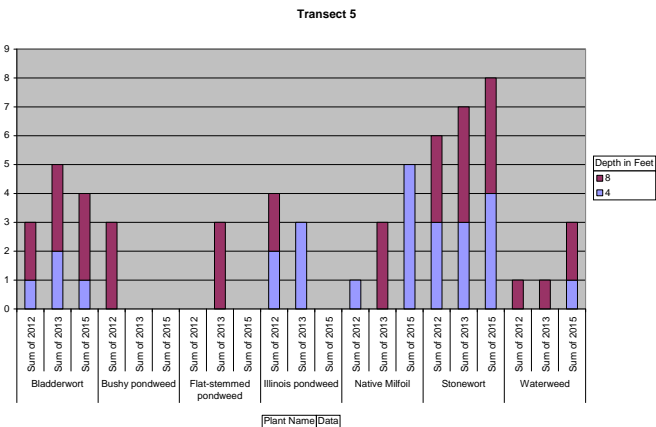
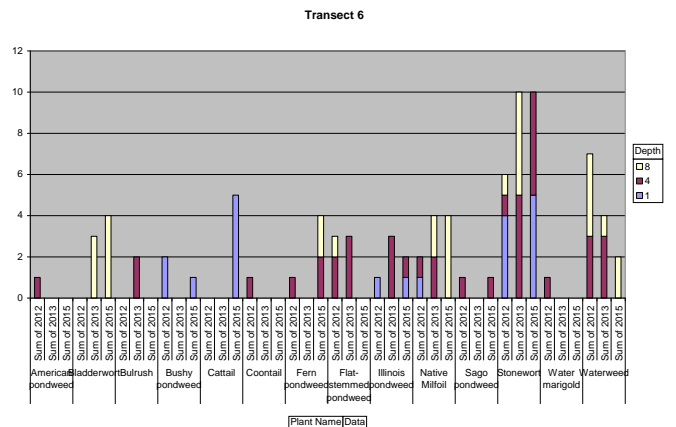
Year to Year Comparison of Weed Sampling by Transect

Charts have been completed for each transect, comparing plants found year to year for your information. These variants demonstrate the randomness of any sampling survey. That we once again found these two plants serves to support the process we've adopted and the need to do this regularly to minimize randomness. What follows in this report is a series of charts summarizing all of the work noted above. These tables show plant types and densities at all transects and all sampling depths. They are organized both by plant type and locations (the 17 transect points).
