2015 Data Report for Ann Lake, Benzie County

Site ID: 100082

Ann Lake, Benzie County **2015 CLMP Results**

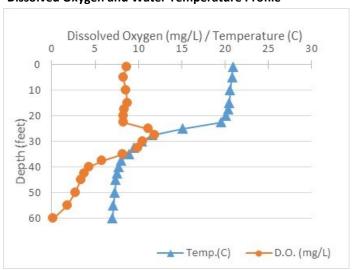
Dissolved Oxygen and Water Temperature Profile

With an average TSI score of 38 based on Secchi transparency, chlorophyll-a, and summer total phosphorus, this lake is rated between the oligotrophic and mesotrophic lake classification. The low level of nutrients in the lake results in dissolved oxygen being available throughout the water column for the most of the summer, but by the end of the summer the very bottom of the lake is anoxic. Long term trends indicate that both phosphorus measurements have increased since monitoring began.

If you enrolled in Dissolved Oxygen/Temperature, the summary page will have a graph of one of the profiles taken during the late summer (typically August or September). A late summer graph is used because dissolved oxygen is often depleted in the late summer, and identifying this condition and the depth at which it occurs is typically the most important use of dissolved oxygen measurements.

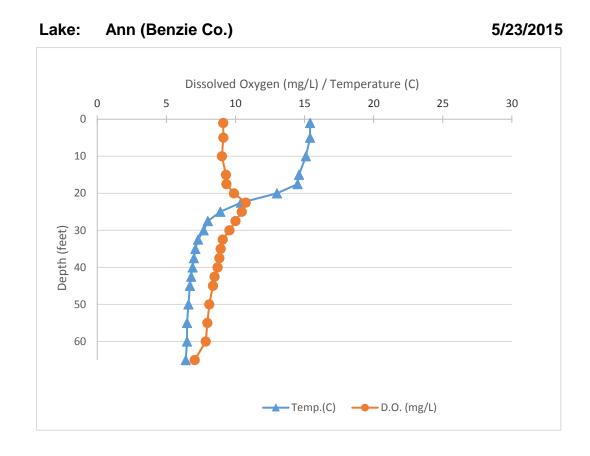
Name: Ann County: Benzie Site ID: 100082 Date: 5/23/2015

| Depth (ft) | Temp.(C) | D.O. (mg/L) |

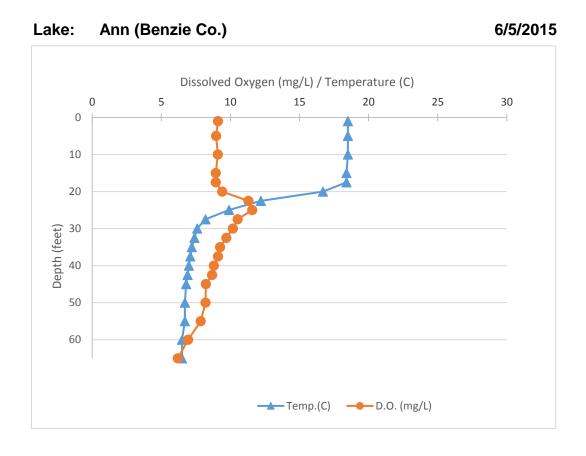
Name: Ann County: Benzie Site ID: 100082 Date: 6/5/2015

| Depth (ft) | Temp.(C) | D.O. (mg/L) |

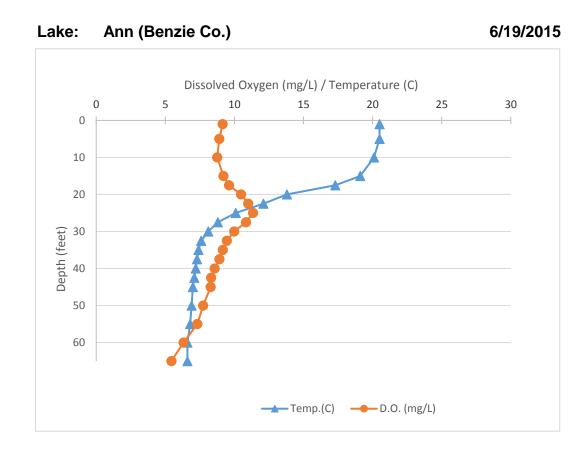
Name: Ann County: Benzie Site ID: 100082 Date: 6/19/2015

| Depth (ft) | Temp.(C) | D.O. (mg/L) |

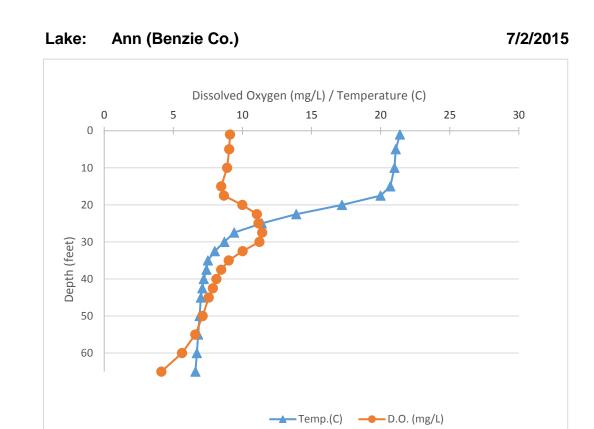
Name: Ann County: Benzie Site ID: 100082 Date: 7/2/2015

| Depth (ft) | Temp.(C) | D.O. (mg/L) |

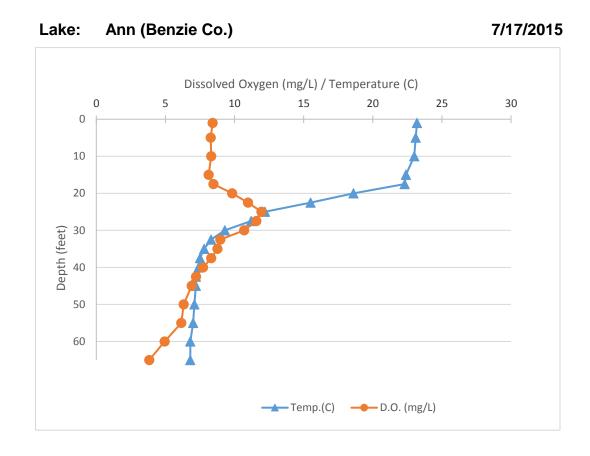
Name: Ann County: Benzie Site ID: 100082 Date: 7/17/2015

| Depth (ft) | Temp.(C) | D.O. (mg/L) |

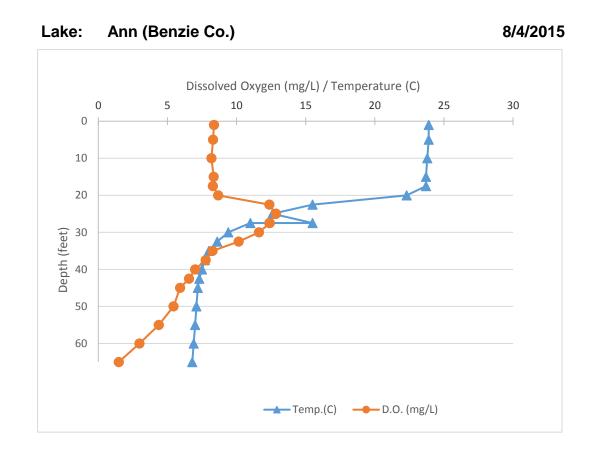
Name: Ann County: Benzie Site ID: 100082 Date: 8/4/2015

| Depth (ft) | Temp.(C) | D.O. (mg/L) |

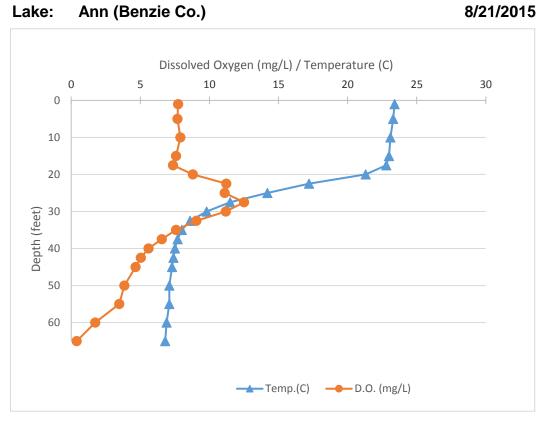
Name: Ann County: Benzie Site ID: 100082 Date: 8/21/2015

| Depth (ft) | Temp.(C) | D.O. (mg/L) |

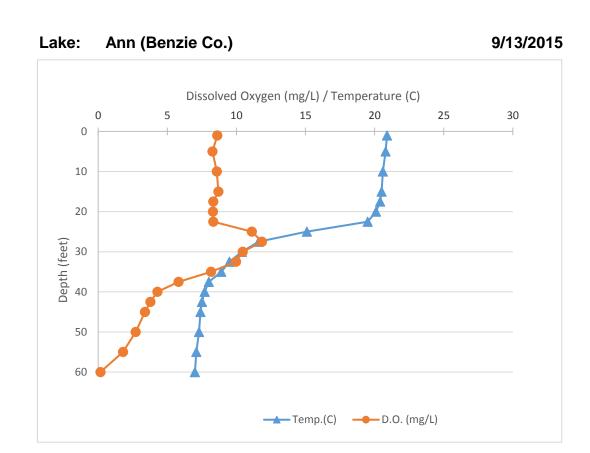
Name: Ann County: Benzie Site ID: 100082 Date: 9/13/2015

Depth (ft) Temp.(C) D.O. (mg/L) 20.9 8.61 5 20.8 8.27 10 20.6 8.58 15 20.5 8.7 20.4 8.33 17.5 20 20.1 8.3 22.5 19.5 8.32 25 15.1 11.12 27.5 11.6 11.85 30 10.4 10.46 32.5 9.5 9.97 35 8.9 8.16 37.5 8 5.81 40 4.29 7.7 7.5 3.77 42.5 45 7.4 3.38 50 7.3 2.71 1.8 55 7.1 60 7 0.16
