**2016 Data Report
for
Ann Lake, Benzie County**

Site ID: 100082

Ann Lake, Benzie County 2016 CLMP Results

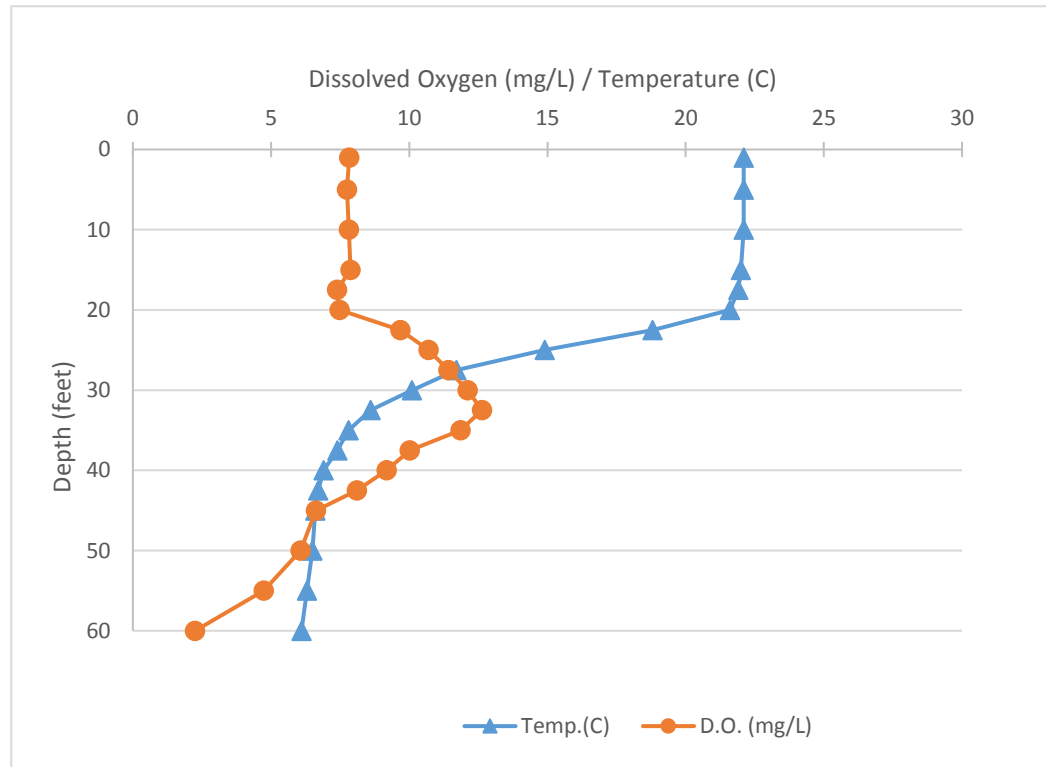
Name: Ann Lake
 County: Benzie
 Site ID: 100082
 Date: 9/11/2016

Dissolved Oxygen and Temperature Profile

Depth (ft)	Temp.(C)	D.O. (mg/L)
1	22.1	7.83
5	22.1	7.75
10	22.1	7.82
15	22	7.87
17.5	21.9	7.39
20	21.6	7.48
22.5	18.8	9.68
25	14.9	10.7
27.5	11.7	11.41
30	10.1	12.11
32.5	8.6	12.63
35	7.8	11.86
37.5	7.4	10.01
40	6.9	9.18
42.5	6.7	8.11
45	6.6	6.62
50	6.5	6.07
55	6.3	4.73
60	6.1	2.25
