2019 Data Report for

Ann Lake, Benzie County

Site ID: 100082

Ann Lake, Benzie County 2019 CLMP Results

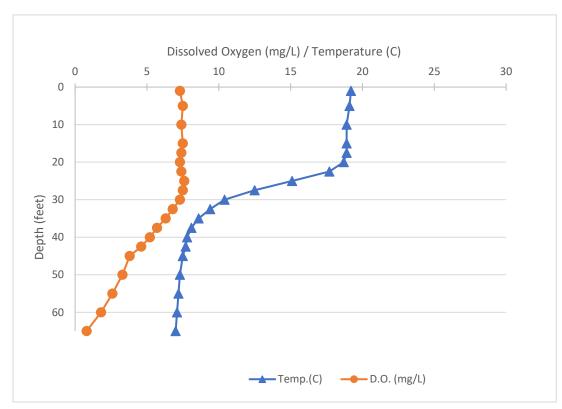
Name: Ann Lake County: Benzie Site ID: 100082 Date: 9/9/2019

Depth (ft)	Temp.(C)	D.O. (mg/L)
1	19.2	7.3
5	19.1	7.5
10	18.9	7.4
15	18.9	7.5
17.5	18.9	7.4
20	18.7	7.3
22.5	17.7	7.4
25	15.1	7.6
27.5	12.5	7.5
30	10.4	7.3
32.5	9.4	6.8
35	8.6	6.3
37.5	8.1	5.7
40	7.8	5.2
42.5	7.7	4.6
45	7.5	3.8
50	7.3	3.3
55	7.2	2.6
60	7.1	1.8
65	7	0.8
