2021 Data Report for

Ann Lake, Benzie County

Site ID: 100082

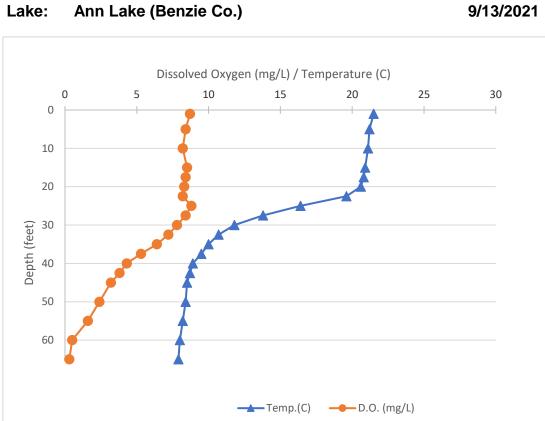
Name: Ann Lake County: Benzie Site ID: 100082 Date: 9/13/2021

Depth (ft)	Temp.(C)	D.O. (mg/L)
1	21.5	8.7
5	21.2	8.4
10	21.1	8.2
15	20.9	8.5
17.5	20.8	8.4
20	20.6	8.3
22.5	19.6	8.2
25	16.4	8.8
27.5	13.8	8.4
30	11.8	7.8
32.5	10.7	7.2
35	10	6.4
37.5	9.5	5.3
40	8.9	4.3
42.5	8.7	3.8
45	8.5	3.2
50	8.4	2.4
55	8.2	1.6
60	8	0.5
65	7.9	0.3
